RED RIVER BASIN STREAM SURVEY REPORT

Red River Basin Stream Survey Report

Sand Hill River Watershed 2006

Thomas P. Groshens

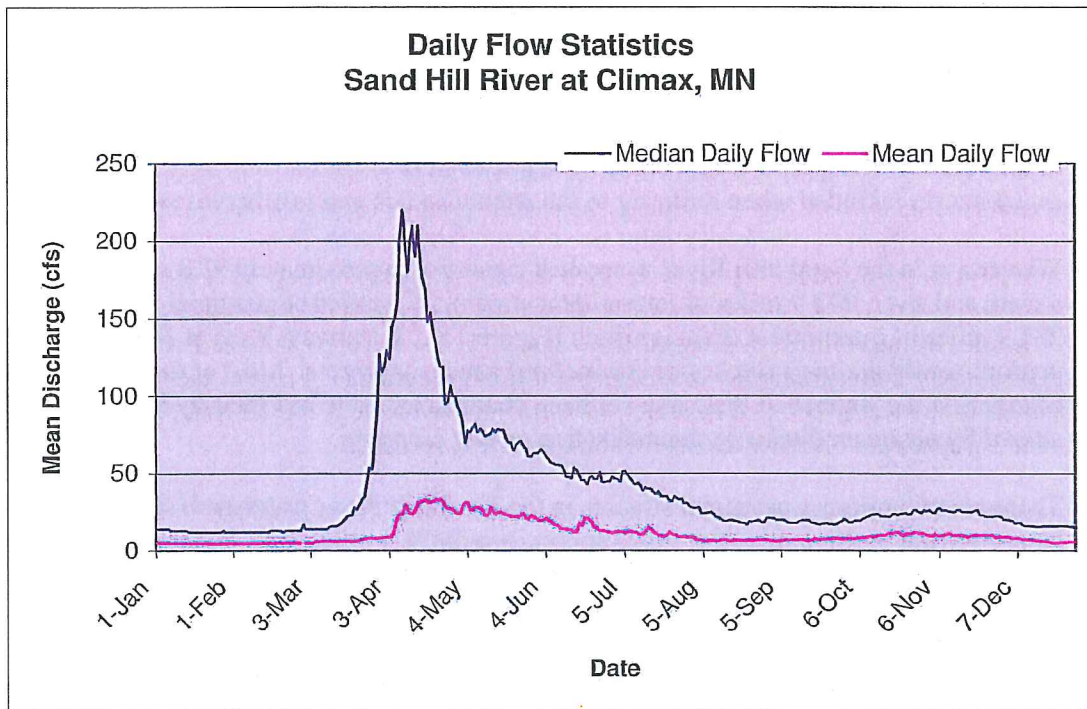
The United States Geological Survey (USGS) currently maintains one active stream flow recording gage station in the Sand Hill River watershed. Gage station #05069000 is located within the city limits of Climax, MN, and has a 420 square mile drainage area. Sand Hill River has a mean annual discharge of 85.3 cubic feet per second (cfs) for the period of record from 1943 through 2004 (Appendix A) as measured at the gage station. The highest instantaneous peak flow recorded at Climax was 4,560 cfs on April 14, 1965 and the annual seven-day minimum is 1.1, which was recorded in January 1962. The 90% exceedance discharge for the period of record at this gage station was 9.1 cfs and the 10% exceedance was 163 cfs (USGS 2004). Daily mean discharges are typically highest in mid-April and lowest in late December through late March (Figure 9).

Figure 9. Mean and median daily mean discharges at USGS gage stations number 05069000 in Climax, MN.

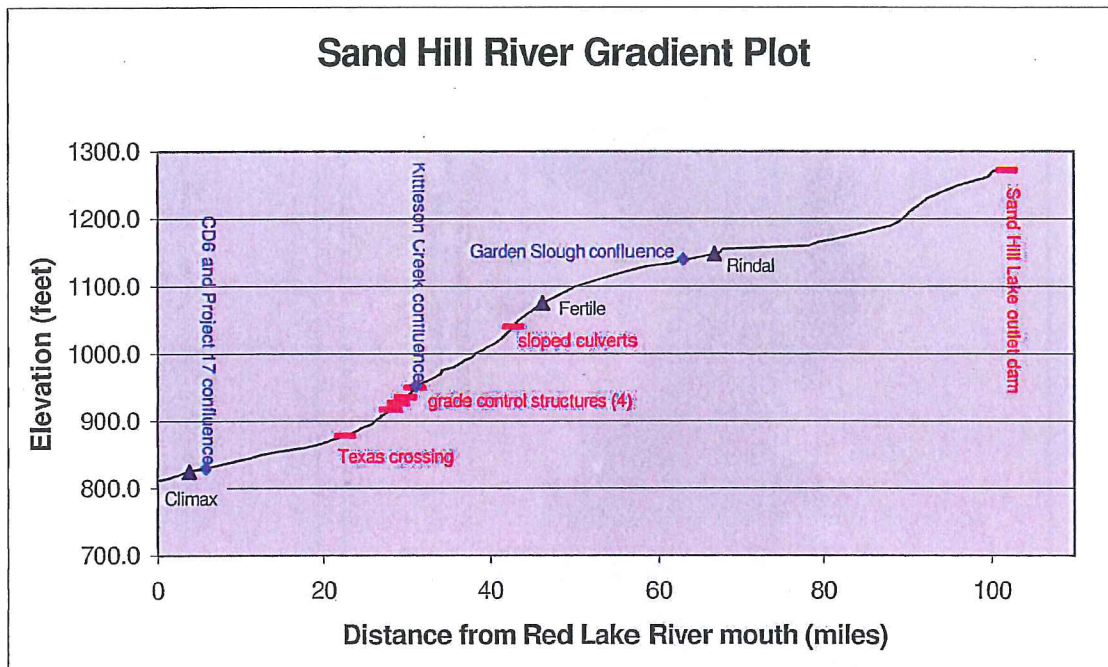
Figure 12. Sand Hill River gradient plot.

Sand Hill River. Sand Hill River originates at the Sand Hill Lake outlet control structure and ends at its confluence with Red River of the North 1.4 miles southwest of Climax, MN.. Huberty (1994) divided Sand Hill River into five Reaches and these same delineated Reaches were used in this survey (Figure 14). For the purpose of this report, a Reach is defined as a segment of stream with relatively consistent morphological characteristics (e.g., gradient, sinuosity, cross-section morphology) and instream habitat is assumed to be similar throughout a Reach. Reach numbering began with the farthest downstream Reach and progressed sequentially upstream.

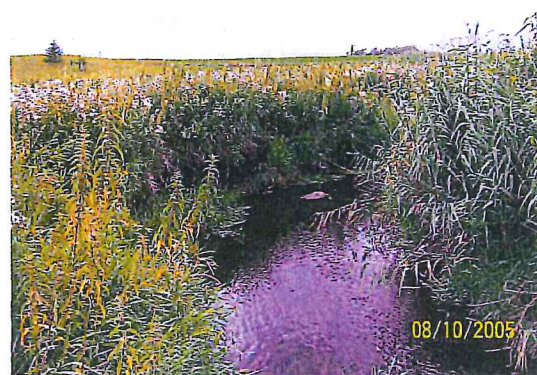
Sand Hill River Reach 5 is a relatively high gradient, low sinuosity stream segment that begins at the outlet to Sand Hill Lake and flows through rolling and undulating agricultural lands (Figure 13). Scattered small lakes and wetlands are common, especially in the upstream half of the Reach. Stream channelization is common throughout this Reach. Major impacts to this Reach include: stream channelization, ditching, and increased sedimentation and accelerated runoff resulting primarily from agricultural land use practices.

Figure 13. Example of Sand Hill River in Reach 5.

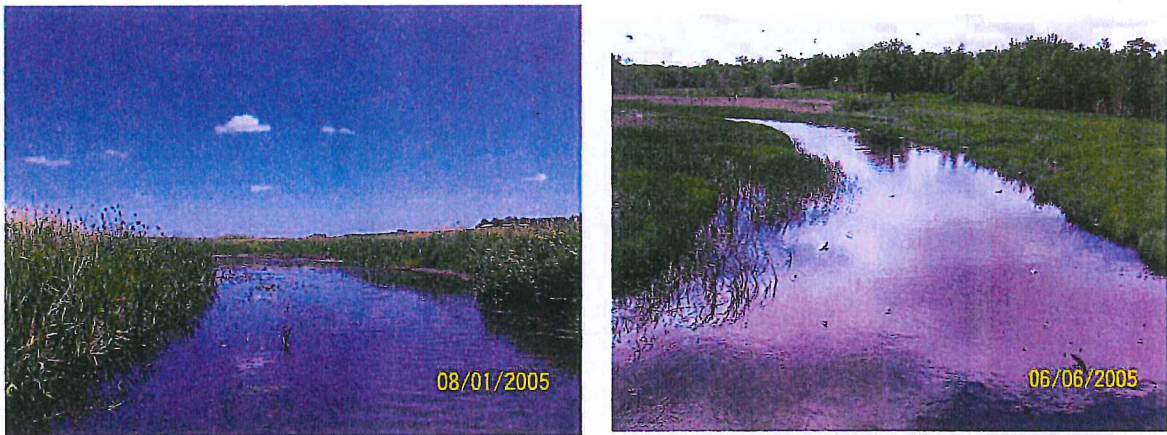
Reach 4 is a low gradient, moderately sinuous stream segment that flows through gently rolling and undulating agricultural lands. Most of this segment meanders through broad wetlands, so there is very little timbered corridor (Figure 15). However, the wetlands are moderately effective at stabilizing the stream banks and reducing flood impacts in the immediate area. Major impacts to this Reach include: increased sedimentation and an altered hydrograph from ditching, channelization and agricultural land uses.

Figure 15. Examples of Sand Hill River in Reach 4.

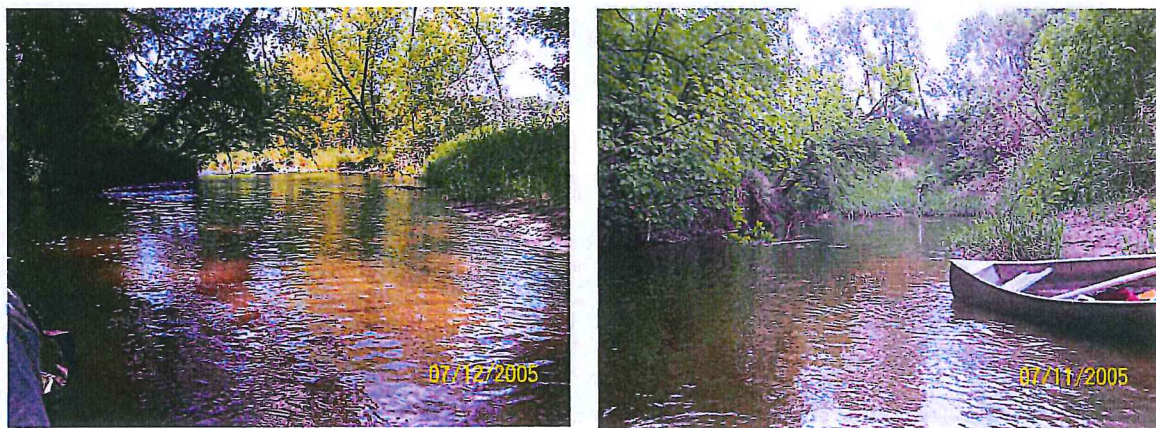
Reach 3 is a relatively high gradient, highly sinuous stream segment. This Reach flows through hummocky and remnant beach ridge topographies, which produce some of the more complex instream habitat in Sand Hill River (Figure 16). Agricultural lands dominate the landscape, however, a timbered stream buffer exists through much, but not all, of this Reach. Major impacts to this Reach include: agricultural impacts, an altered hydrograph, stream connectivity impacts (e.g., fish passage barriers) from the “sloped culverts”, and urban impacts associated with the city of Fertile.

Figure 16. Examples of Sand Hill River in Reach 3.

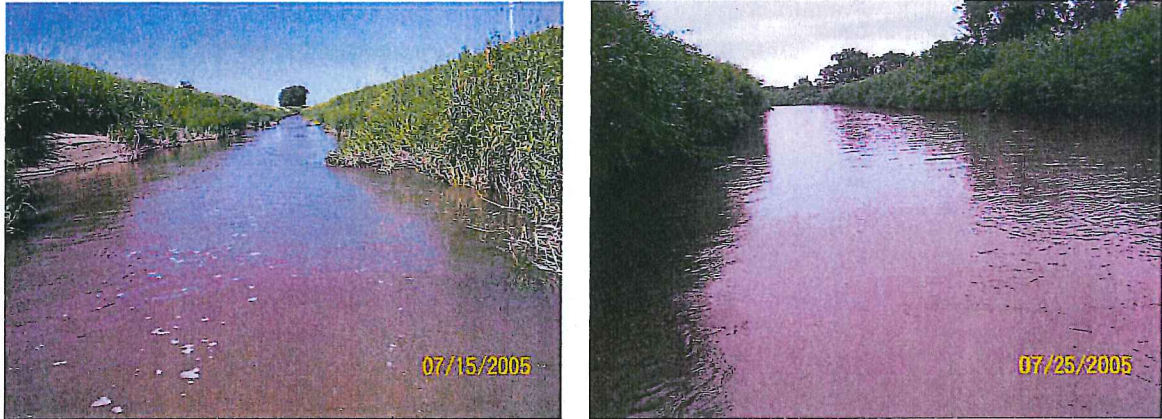
Reach 2 is a relatively high gradient, channelized stream segment flowing through the glacial Lake Agassiz plain (Figure 17). Agricultural lands dominate the landscape surrounding this Reach and row cropping is prominent. Instream habitat consists primarily of run habitat and very little timbered stream buffer exists. Major impacts to this Reach include: stream channelization, hydrologic impacts due to altered hydrograph, stream connectivity impacts caused by the “Texas crossing” and the four grade control structures described earlier, and agricultural impacts.

Figure 17. Examples of Sand Hill River Reach 2.

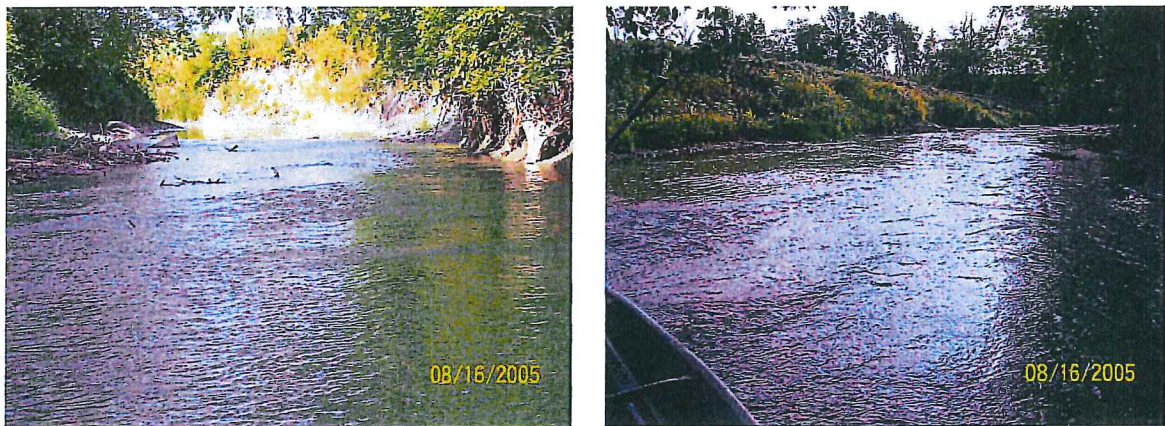
Reach 1 is a low gradient, highly sinuous stream segment that meanders through the glacial Lake Agassiz plain (Figure 18). Agricultural lands dominate the landscape and row cropping is prominent. The stream buffer in the downstream half of Reach 1 is generally timbered and wide on both sides of the stream, however, the upstream half is generally narrow and ineffective at slowing surface runoff, stabilizing stream banks, or filtering runoff. Major factors impacting this Reach include: urban impacts associated with the city of Climax, hydrologic alterations and agricultural impacts (e.g., increased runoff and sedimentation).

Figure 18. Examples of Sand Hill River Reach 1.

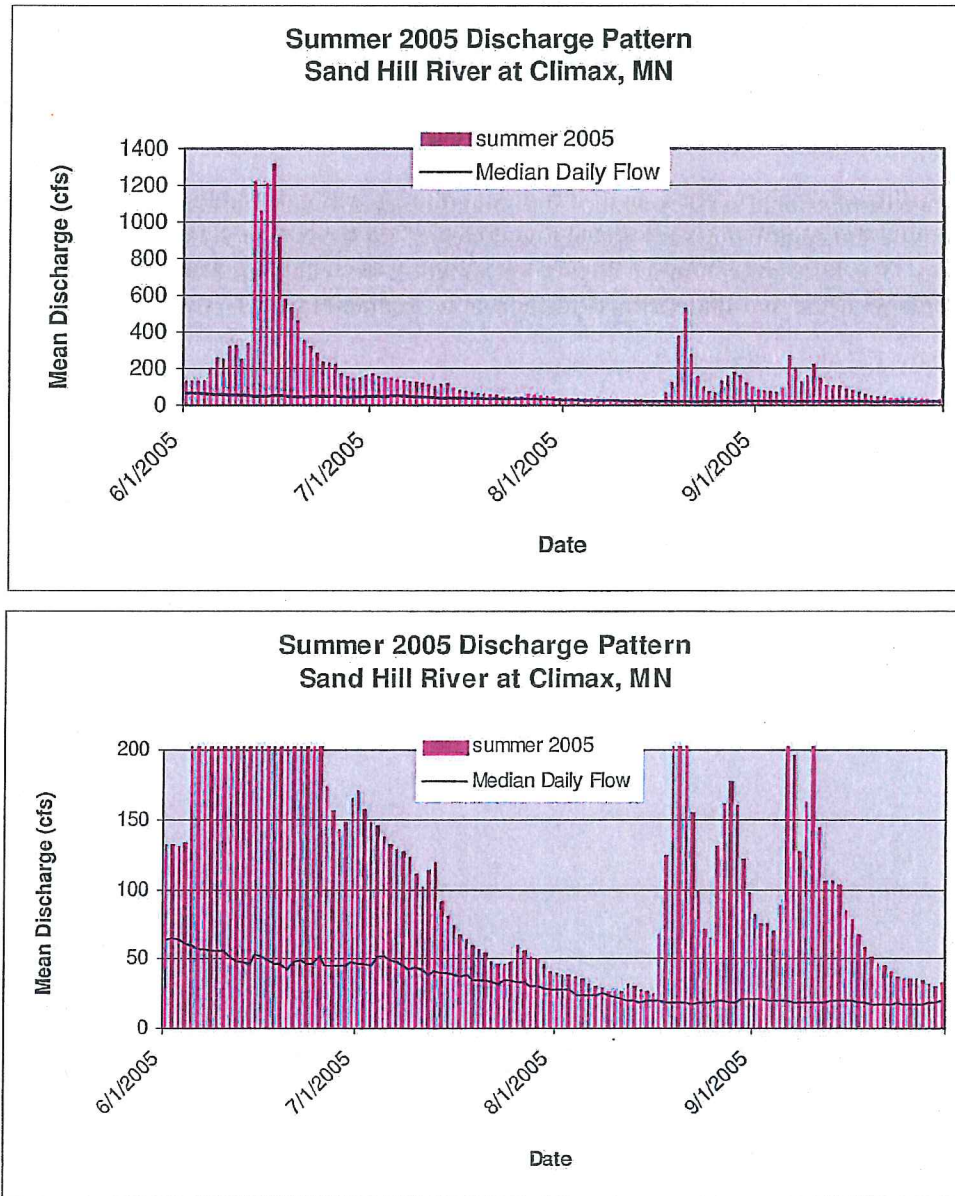
Stream flows through most of the summer of 2005 were substantially above median flows at the USGS gage station on Sand Hill River in Climax, MN (Figure 20). Stream flows were not monitored on other streams in the watershed. However, stream flows ranging from bankfull flows to extreme low flow were observed on most of these streams.

Figure 20. Sand Hill River stream discharge pattern from June 1, 2005 to September 30, 2005. Values on the lower graph were limited to those 200 cfs and less in order to facilitate comparison of discharges to historical median flows

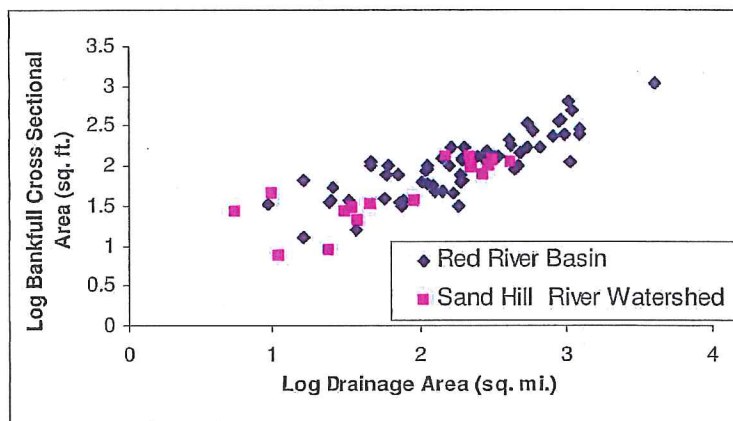
Bankfull Width and Depth: The narrowest bankfull width estimate was 5.8 feet at station KC112 and the widest was 56.6 feet at SHR311 on Sand Hill River. Bankfull widths were correlated to drainage area ($r=0.64$). Bankfull cross-sectional areas ranged from 7.5 ft² at UK100 to 129.9 ft² at SHR410. Bankfull cross-sectional areas were correlated with drainage area ($r=0.84$) and comparable to those of other streams in the Red River basin (Figure 21; MN DNR, unpublished data). Stream channel width-to-depth ratios ranged from 3.8 at KC112 to 47.6 at GS100. Mean bankfull depths ranged from 0.5 ft at UK100 3.5 ft at SHR111.

Figure 21. Relationship between drainage area and bankfull cross-sectional area for sample stations in the Sand Hill River watershed and other stations throughout the Red River basin.

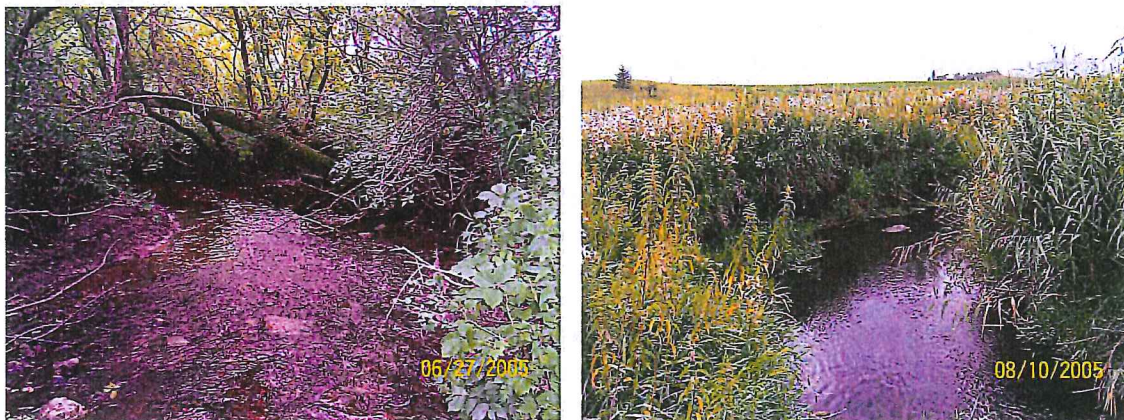
Entrenchment: Flood prone widths ranged from 14.8 feet at UK100 to greater than 600 feet at SHR410 (Table 4). The stream was either entrenched or moderately entrenched (entrenchment ratios ≤ 2.2) at eight stations and slightly entrenched at eight stations (entrenchment ratios > 2.2 ; Table 4). The lowest entrenchment ratio (1.0) was found at UK100 while the highest (approximately 31.0) was found at Sand Hill River station SHR511 (Figure 22).

Figure 22. Station UK100 (left), located on an unnamed tributary stream to Sand Hill River, and station SHR511 on upper Sand Hill River (right).

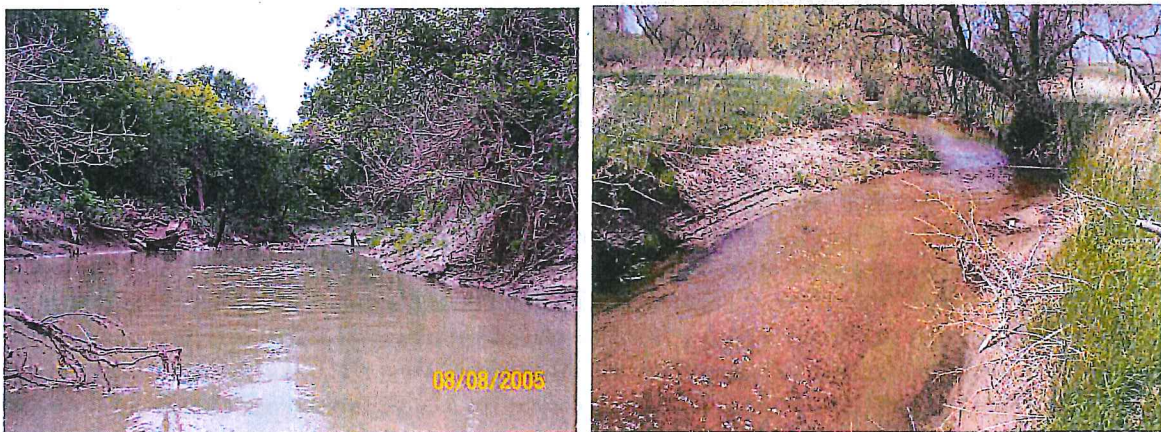
Channel stability was poor at three of the five stations located on F type channels (SHR110, SHR210 and UK100). These stations had near vertical stream banks with frequent areas of mass wasting on the upper stream banks and extensive lower bank erosion as primary contributing factors (Figure 23). In addition, the stream bottom at these stations was comprised of loose, unconsolidated materials with few, if any, stable materials present.

Figure 23. Unstable stream channels at stations SHR110 (left) and KC111 (right).

Channel stability was poor at one of the two stations located on G channels (KC111) and fair at the other (KC110). The stream bottom at both stations was comprised of loose, unconsolidated materials, however, there was noticeably more lower bank erosion and within-channel scour was noticeably worse at KC111 compared to KC110.

The streams in the Sand Hill River watershed have the capacity to provide a variety of high quality habitats for fish and other animals. Hydrologic conditions and unstable channels limit many stream reaches from achieving their potential. The recommended activities listed below will help improve the quality of waterways and the condition of aquatic communities in the Sand Hill River watershed. Activities should be implemented progressing from upstream to downstream whenever possible.
